L A S C E L L E S  
ENGINEERING & ASSOCIATES LIMITED  
1010 SPENCE AVE. SUITE 14, HAWKESBURY, ONTARIO K6A 3H9  
OFFICE: (613) 632-0241

Our file Reference: 200176

May 13, 2020

Subject: Foundation Inspection Report  
3440 County Road 10, Vankleek Hill, Ontario

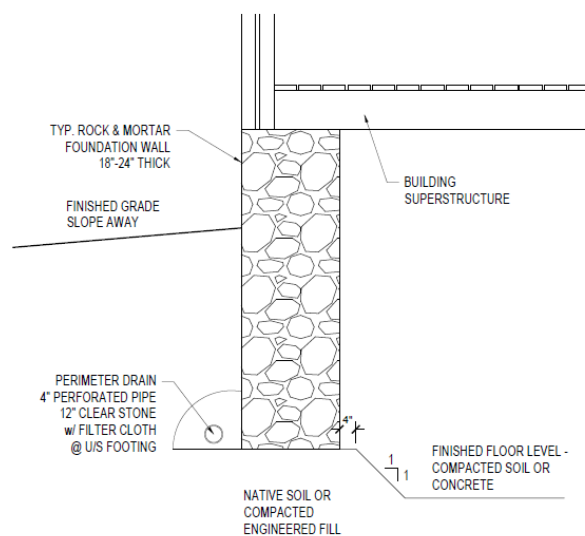
Figure 01 – Recommended berm at base of foundation wall

In the near term (<1 year), Lascelles recommends that the soil beneath and around the foundation walls be restored such that there is a berm extending 100mm from the interior face of foundation wall before being sloped at a 1:1 ratio to the basement floor elevation. See Figure 01 for a typical detail. As the sump pit is the low point around the house, water will continue to infiltrate under the foundation wall and accumulate at this location. Regular maintenance of the berm will be required.

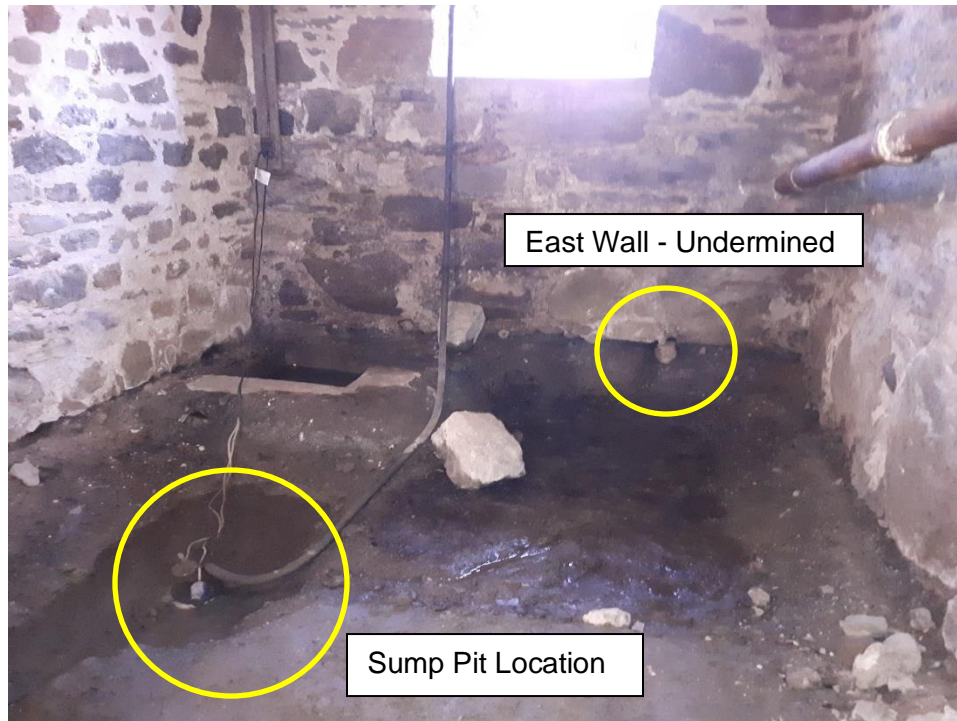
Water accumulation was observed inside the Eastern foundation wall, at the approximate mid-point between North and South facing walls. It appears that the lowest point of the basement floor has been excavated to below the water table elevation. A sump pump and bucket has been implemented at the low point of the basement to allow for extraction of the water. Based on the height of the water table, the pump is likely to run on a constant basis to maintain low water levels. The sump location is now the low point around the house, and therefore water will continue to migrate to this location unless the original floor height is restored.

Figure 02 – Majority of water accumulation in middle basement segment along East wall.

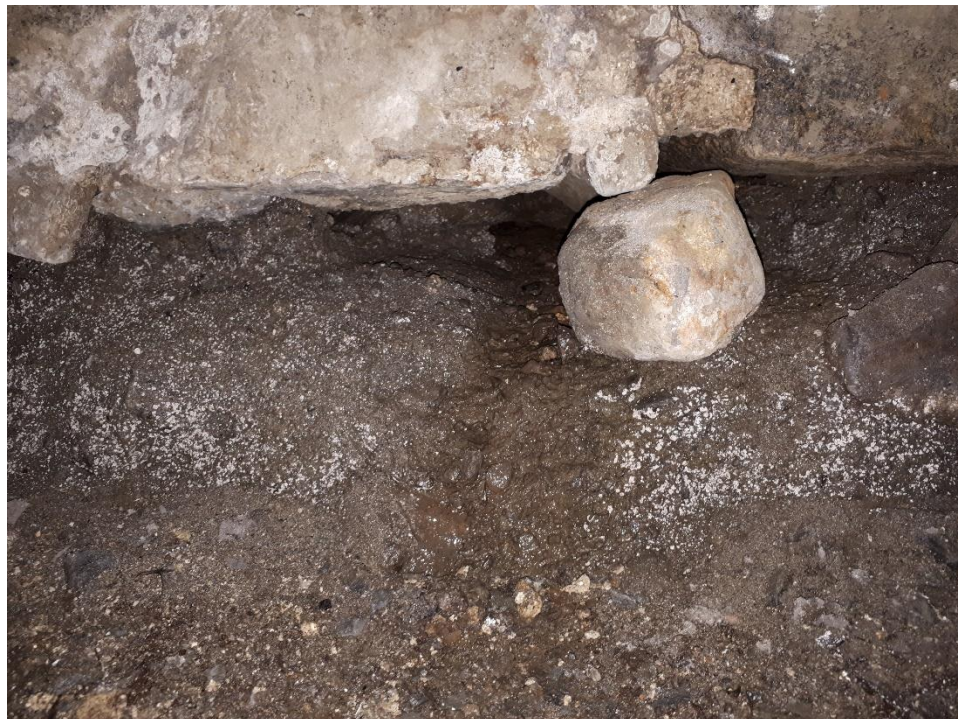
Lascelles observed two locations where water was actively flowing beneath the foundation wall. The apparent primary infiltration point was located immediately adjacent to the sump pit area, passing underneath the Eastern foundation wall. Undermining of the foundation was observed around a point of water flow, suggesting that the water infiltration had resulted in erosion of soils beneath the foundation wall.

Figure 03 – Water infiltration and erosion under East foundation wall, adjacent to sump pit area.

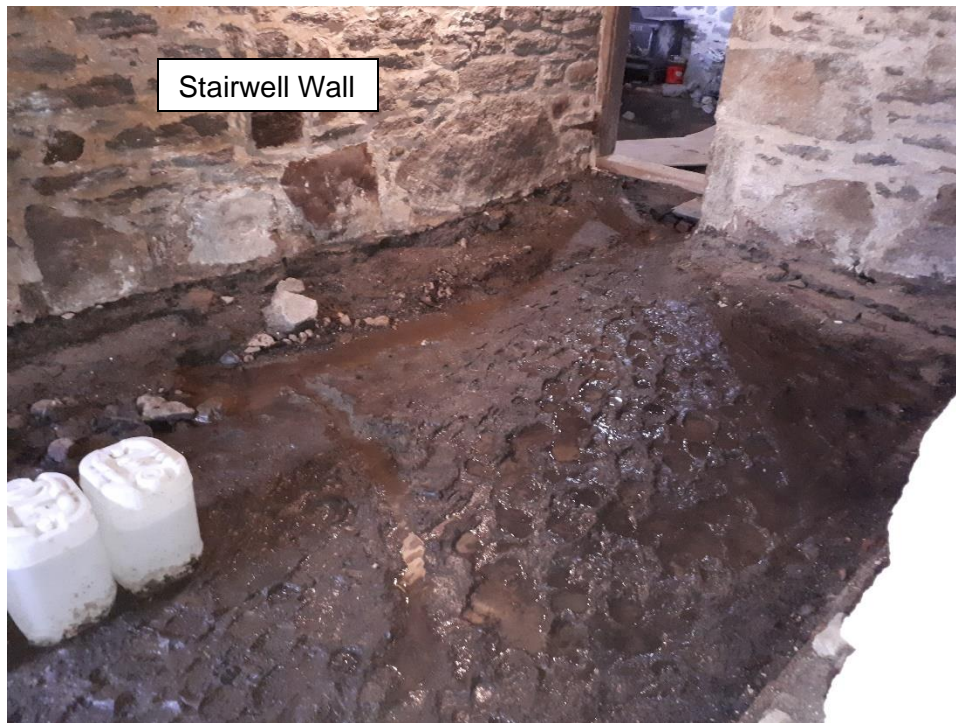
*Figure 04 – Foundation segment adjacent to access stairs (interior view). Water accumulation on the floor. Drainage has been dug with slope towards sump pump.*

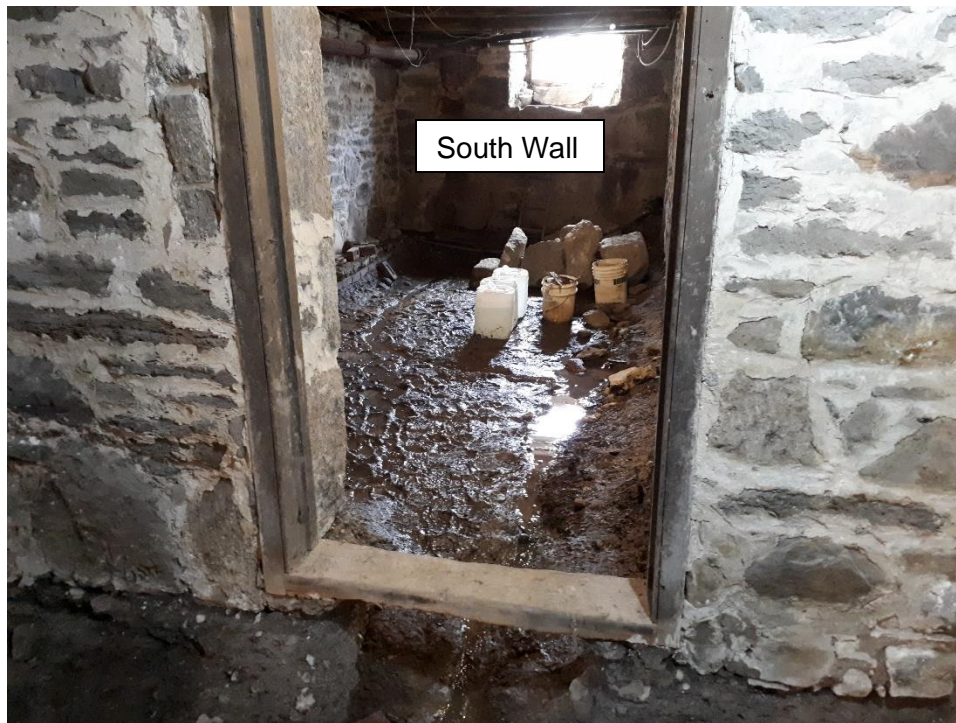
*Figure 05 – Foundation segment adjacent to access stairs (exterior view). Water accumulation on the floor. Drainage has been dug with slope towards sump pump*

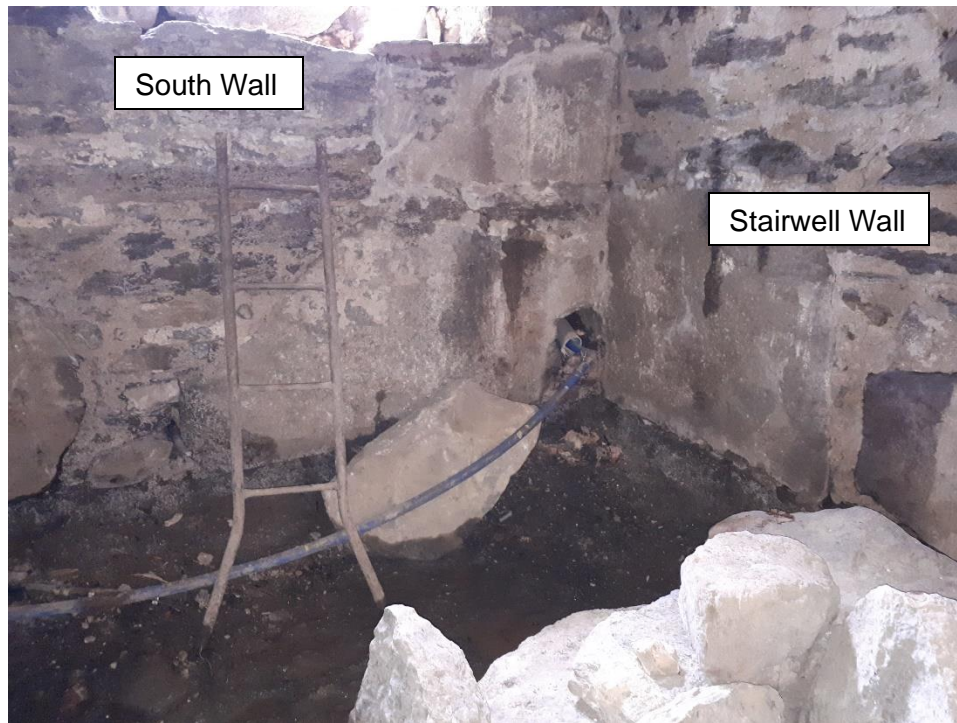
A secondary infiltration point was located beneath the South foundation wall near the basement entrance. The observable flow was much less than in the primary location, and minimal erosion/undermining was observed in any singular location.

*Figure 06 – Water infiltration underneath South foundation wall is evident, although exact location could not be established.*

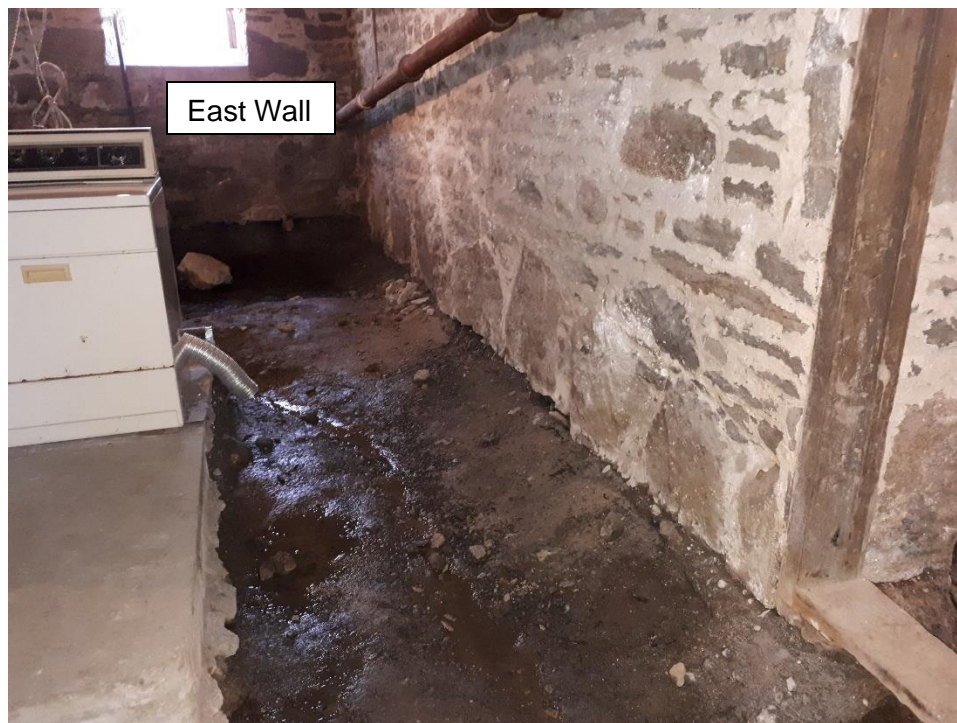
*Figure 07 – Middle basement segment facing East wall. Water drainage path dug in floor, sloping to sump pump.*

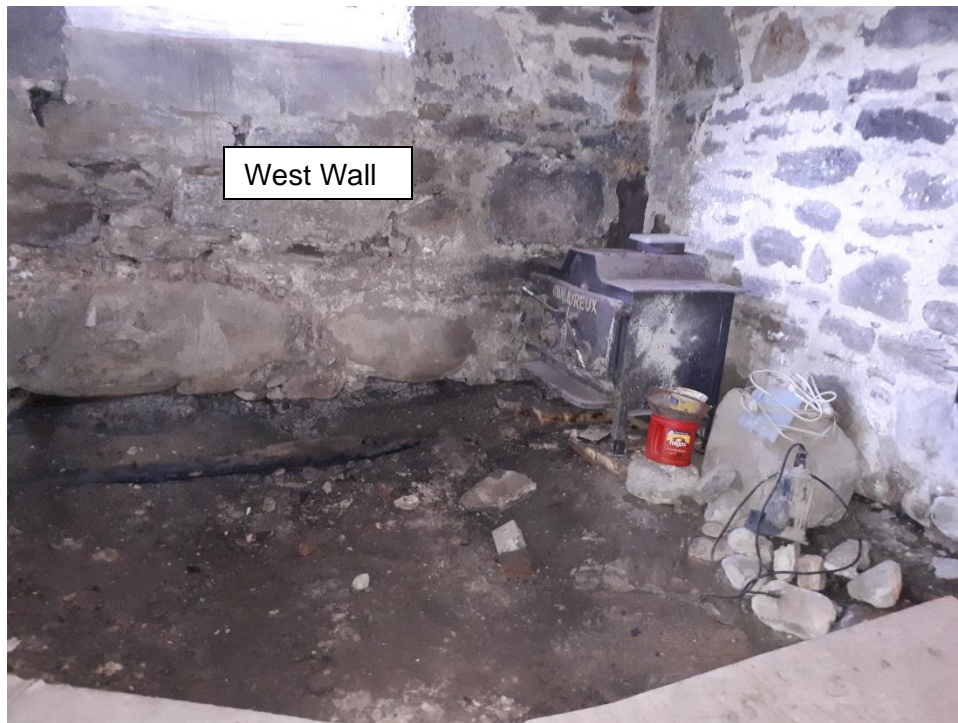
*Figure 08 – Basement floor dry along West foundation wall.*

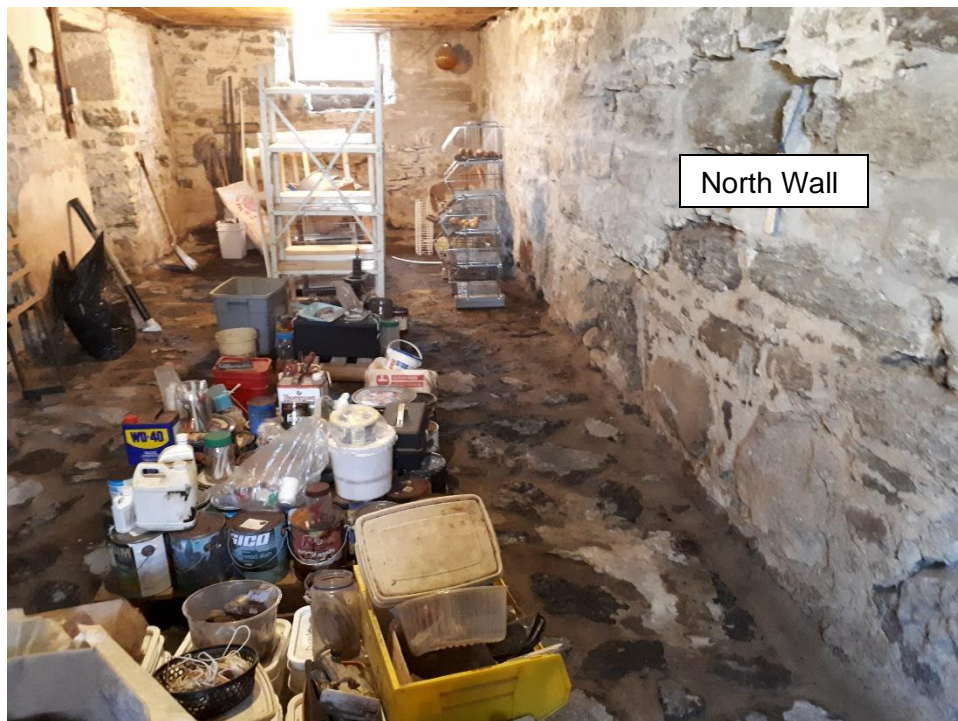
*Figure 09 – Basement floor dry in Northern segment of basement.*
